Report No. DODIG-2012-132 September 14, 2012

United States  
Department of Defense

## Project Planning Resulted in Outstanding Building Deficiencies and Decreased Functionality of the Main Fire Station at Naval Station Great Lakes

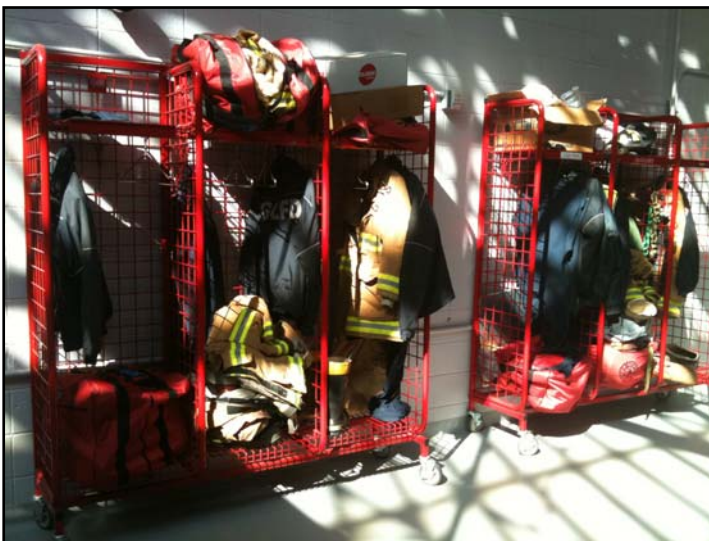
**Figure 2. PPE in Stored in Open Bay and Exposed to Direct Sunlight After the Renovation**

The storage area for PPE in the fire station did not comply with the manufacturer's requirements for storage and maintenance of equipment or the UFC for Fire Stations, which increased the firefighters' risk of injury. PPE, which includes protective garments worn by firefighters, was designed to protect individuals against health and safety hazards. According to the Fire and Emergency Manufacturers and Services Association, Inc., exposure to direct sunlight will cause the materials in the protective ensemble to deteriorate, and proper storage of the PPE can extend its life, maintain its performance, and reduce potential health hazards. The manufacturer for the PPE worn by Great Lakes firefighters stated that improper storage may result in damaged PPE and could increase the risk of death, burns, injuries, diseases, and illnesses. The UFC for Fire Stations

requires PPE to be stored in a negatively pressurized<sup>10</sup> room with a dedicated exhaust vented to the outside to ensure emissions from the equipment are vented directly outside, instead of into the fire station. Before the renovation project, firefighters stored PPE in enclosed lockers located inside the physical training room. While the training room was not a negatively pressurized room, the PPE was not exposed to sunlight when stored. However, after the renovation project,

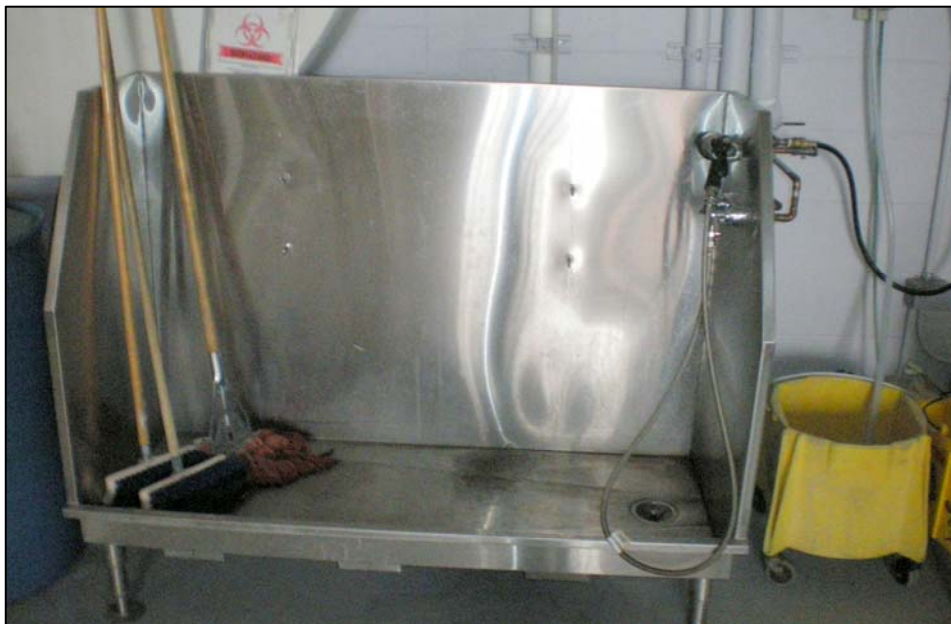
**Figure 3. Wash and Disinfection Area Located in an Open Bay**

The fire station did not have an adequate wash and disinfection room where firefighters could safely clean equipment without being exposed to potentially hazardous materials. The UFC for Fire Stations requires fire stations to have a negatively pressurized wash and disinfection room adjacent to the maintenance area with a dedicated wash-off area where firefighters can wash, desalinate, and dry incoming equipment. In addition, the wash and disinfection room must have at least a three-compartment stainless steel sink and a stainless steel work table. Before the renovation, the fire station had a wash and disinfection room located adjacent to the apparatus bay. After the renovation, the fire station did not have a dedicated room to safely clean equipment. Instead, the fire station had a wash and disinfection area with a single-compartment sink in the apparatus bay, which was an open area. Fire station officials stated that they use this sink to wash and disinfect equipment, as well as wash mops and brooms that they use to clean the fire station. Figure 3 (on page 9) shows the wash and disinfection area in an open bay with mops and brooms that firefighters used to clean the fire station.

The wash and disinfection room did not meet the requirements of the UFC for Fire Stations and increased firefighters' exposure to potentially harmful chemicals. The fire station should have a wash and disinfection room that meets the requirements of the UFC for Fire Stations to mitigate health and safety risks for firefighters.

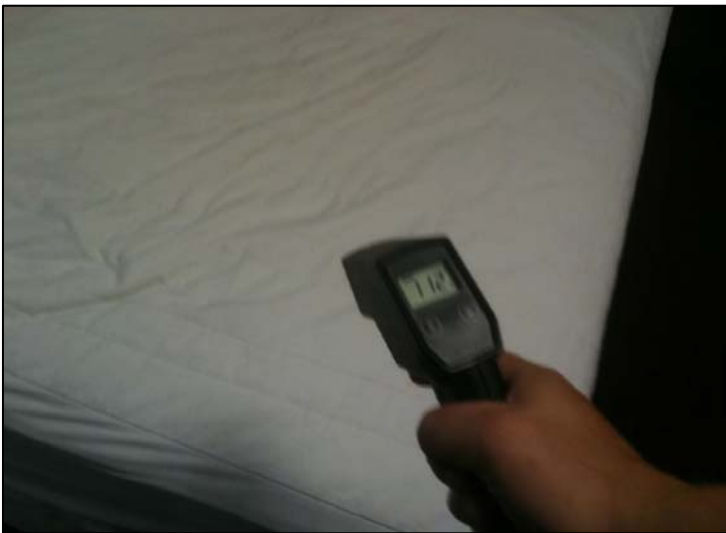
**Figure 4. Temperature Inside a Dorm Room Exceeded 100 Degrees Fahrenheit**

*Firefighters stated that during the winter, temperatures inside the dorm rooms reached 55 degrees Fahrenheit and, during the summer, temperatures reached 112 degrees Fahrenheit...*

112 degrees Fahrenheit, as shown in Figure 4. Before the renovation, a radiator regulated the temperature in the fire station. After the renovation, the dorm rooms had a centralized thermostat control, but problems with the heating and air conditioning made the rooms extremely uncomfortable and almost uninhabitable. When firefighters respond to emergency calls, their ability to perform their work is directly tied to how rested they are. Living conditions in the fire station did not provide a comfortable and relaxing environment, which may affect the performance of the firefighters when responding to emergencies. According to the Naval Station Great Lakes Fire Chief, NAVFAC Midwest and the contractor repaired the condenser, condenser fan, and computer board for the HVAC system. Additionally, NAVFAC Midwest officials and the contractor verified temperature readings in September 2011. However, according to the Naval Station Great Lakes Deputy Fire Chief, as of April 2, 2012, neither the contractor nor NAVFAC Midwest corrected the HVAC issues. The Deputy Fire Chief stated that firefighters continue to experience problems with the temperatures throughout the fire station. On April 11, 2012, NAVFAC Midwest officials stated that they would work with the Great Lakes Fire Department to address the temperature issues in the dorm rooms.

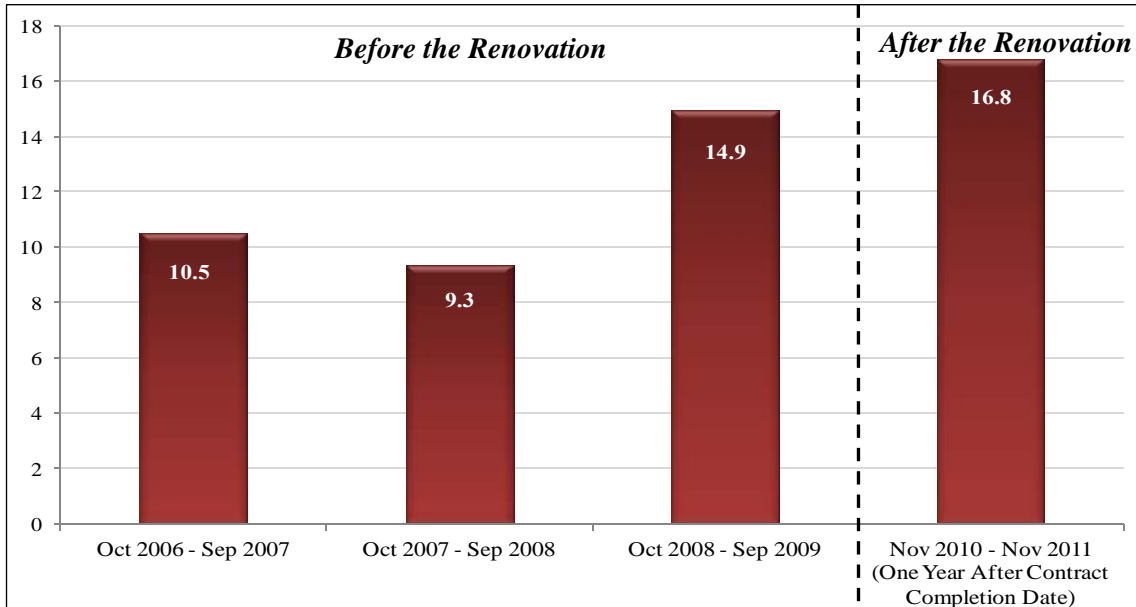
**Figure 6. Average Number of Monthly Maintenance Requests\*  
for the Fire Station**

We evaluated the average number of monthly maintenance requests before and after the renovation and determined that the average number of monthly maintenance requests increased after the contractor completed the renovation. Post-renovation maintenance logs identified repetitive problems occurring throughout the fire station, including problems with pest control, electricity, plumbing, and HVAC, as well as water leaking from the roof of the fire station. Figure 6 (on page 20) displays the average monthly number of the maintenance requests before and after the renovation.

As shown in Figure 6, the average number of monthly maintenance requests recorded after the renovation was higher than the average number of monthly maintenance requests for any of the 3 years before the renovation. Additionally, the average number of monthly maintenance requests for the 1 year after the renovation increased 13 percent, when compared to the year before the contract start date. Consequently, even after spending \$5.48 million on the renovation project, the Navy had to invest additional funds to address increased maintenance requests.
